Weaver Residence Wind Turbine Noise Assessment

February-March, 2013

This report outlines the findings of an informal wind turbine noise assessment at the Weaver residence at 7624 Wellington Road 12 just south of Arthur, ON.

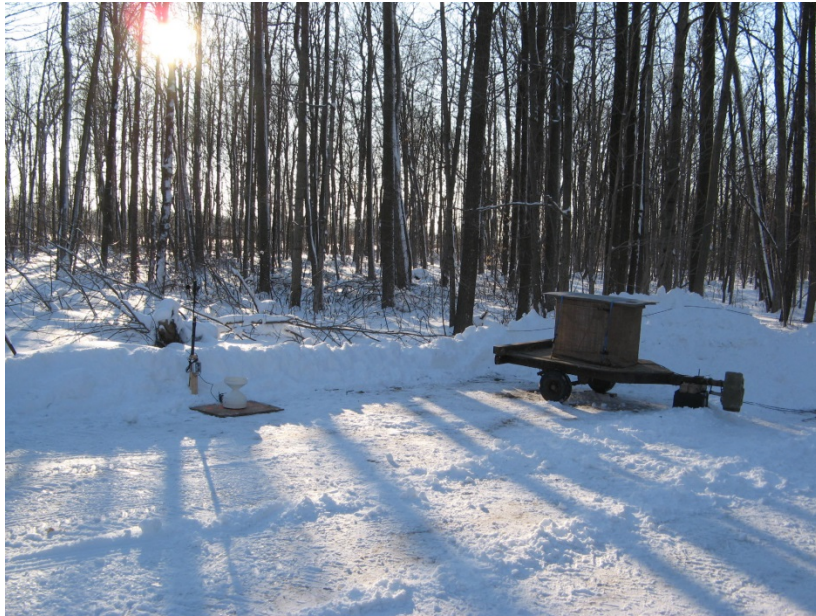
Figure 1 – Noise measurement location at the Weaver residence near Arthur, ON. 723 m away from the nearest IWT. Nearby: ONSET Wind Speed/Direction Smart Sensor model S-WCA-M003 with Onset HOBO Micro Station logger model E348-H21-002. Also, a tipping bucket rain gauge is co-located with the wind sensors. Microphone locations are situated in sheltered areas. Location: N4847853 E534398

In the following part of the report, the results are paired for the two sites shown in Fig's 1 & 2. Figure 1 shows the microphone location

at the Weaver residence while Figure 2 shows the microphone location as a similar background site, approximately 10 km from the nearest IWT.

sheltered from rain and other elements by a 21" X 36" X 30" (0.5 X 0.61 X 0.76 m) wire crate covered with burlap fixed tight to avoid flapping sounds (Figs 1 & 2). The crate was covered by two layers of plywood with a sheet metal drip tray in between. A foam covering was contemplated but it has been found by others² that an enclosure of 1 inch acoustical foam can reduce measured dBA values by 2 to 3 dB. While this microphone protection is not required by MOE requirements, it is useful to protect the microphone from the elements that might otherwise interfere with the measurements or damage the hardware. The burlap has an open weave that easily allows sound to pass through.

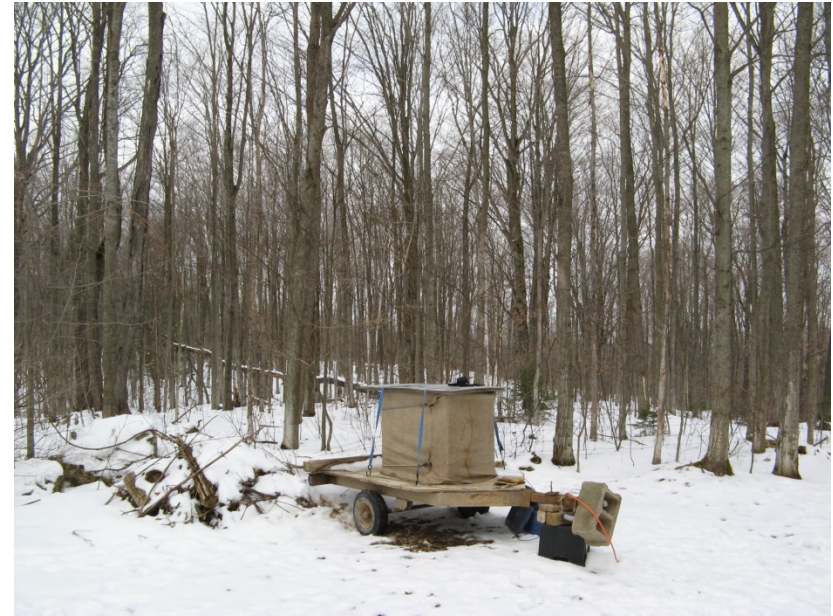
Figure 2 - Background noise location & setup: in a small clearing east of Eugenia Lake, Grey Highlands, ON. This site was chosen to be closely comparable to the Weaver location near Arthur. The microphone is located in a burlap wrapped wire crate on a trailer. Location: N4909221 E542872

The setup on the trailer has the advantage of having a consistent setup from one location to another and can be used in any kind of weather. Placing the microphone in a sheltered location instead of the 4.5 m height as required by the MOE is even more important to reduce unwanted wind noise on the rig & the windscreens. This can also prevent problems from temporary setups. For example, at MOE noise monitoring station near Clear Creek and Underwood, Ontario, loud noise emanated from the microphone support towers and rigging similar to wind noise in the rigging of a sailboat in high wind. This noise was louder than any noise from trees or the nearby IWT's when standing beside the towers.

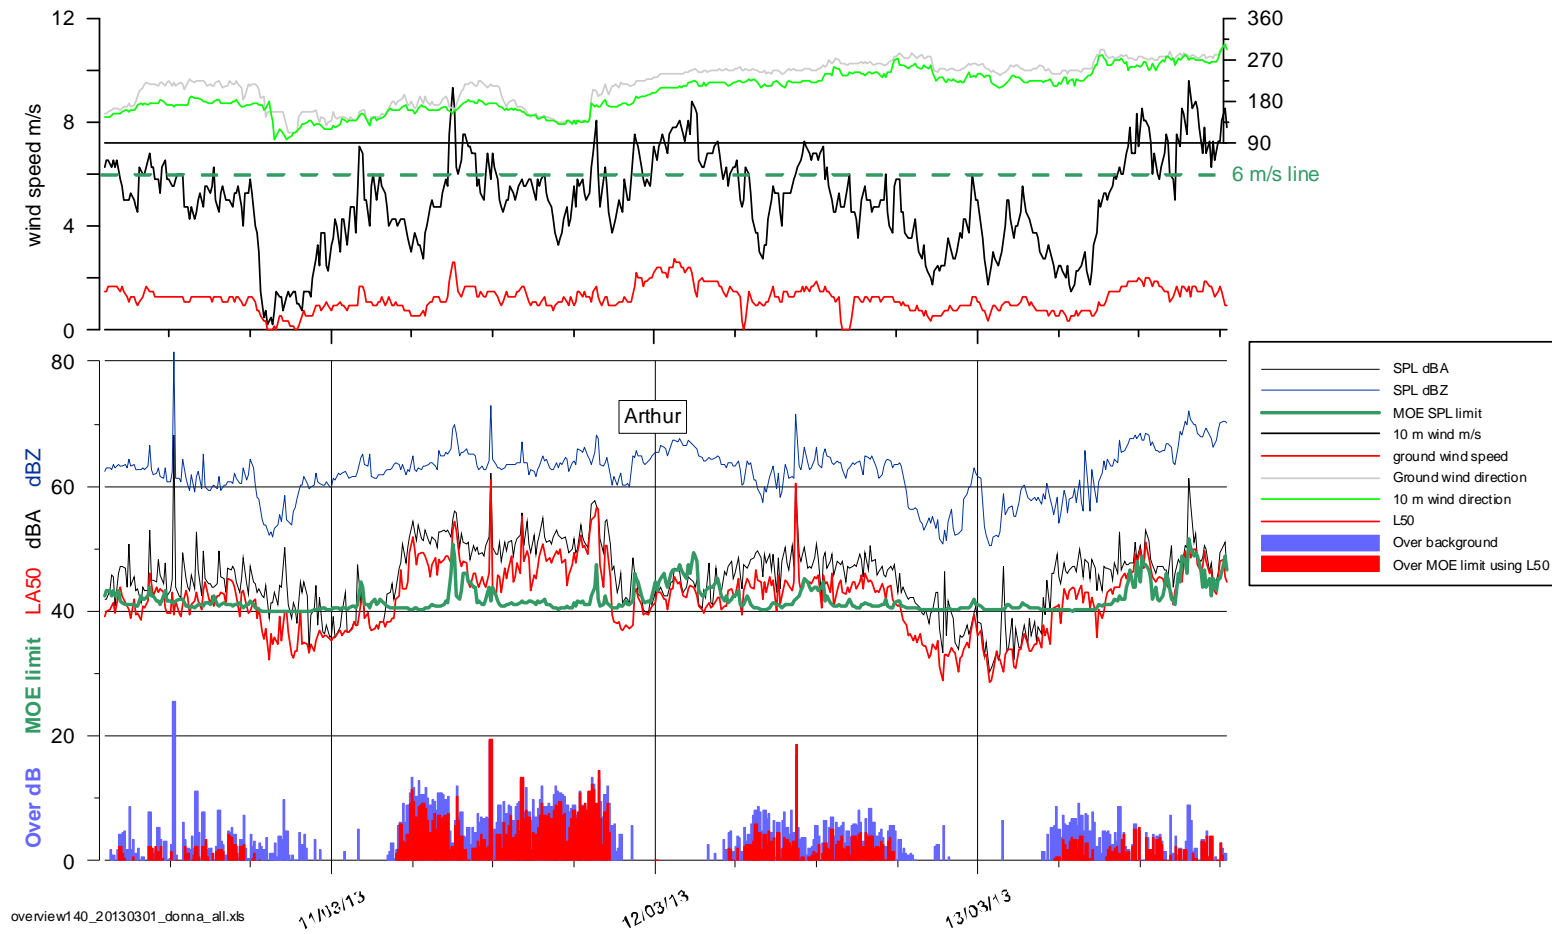
Figure 6 – Detailed record for March 10 – 13, 2013 at the Weaver residence. As noted above, subtracting the MOE limit from the A-weighted SPL may over-estimate the degree of non-compliance with the MOE noise limit. Instead of using the Leq, the L50 can also be used. The L50 value is the median SPL in each 10 minute record. Generally, it was observed that loud traffic noise was not present more than 50% of the time and thus L50 is only the IWT generated noise that is present to raise the SPL level above that of the background site for the same 10 m wind speed. In the bottom graph, the L50 is plotted as a red line and when the MOE limit (green line) is subtracted from the L50, the red bar graph results along the bottom axis. Compared to the blue non-compliance graph as in Fig. 5 (reproduced here), the duration and magnitude are lower as expected **but even the L50 exceeds the MOE allowable noise 24% of the time**. Figure 7 will show the entire record. Figure 6 shows the futility of the MOE approach to determining compliance – i.e. by listening to sporadic recordings to see if IWT noise can be heard over the background noise when the measured SPL is over 40 dBA. It is for the most part impossible to distinguish IWT noise from background noise by simply occasionally listening to recordings for “selected” times. **A long term record is obviously required for a proper assessment.**

The red bar graph along the bottom x-axis in Figs. 6 & 7 represent the **L50** values that are located above the logarithmic sum of the MOE limit (green line) and the background noise (solid black line in Fig. 8; broken black line above). **The amount of time that L50 exceeds the MOE noise limit is 24% of the time between February 9 and March 16, 2013**

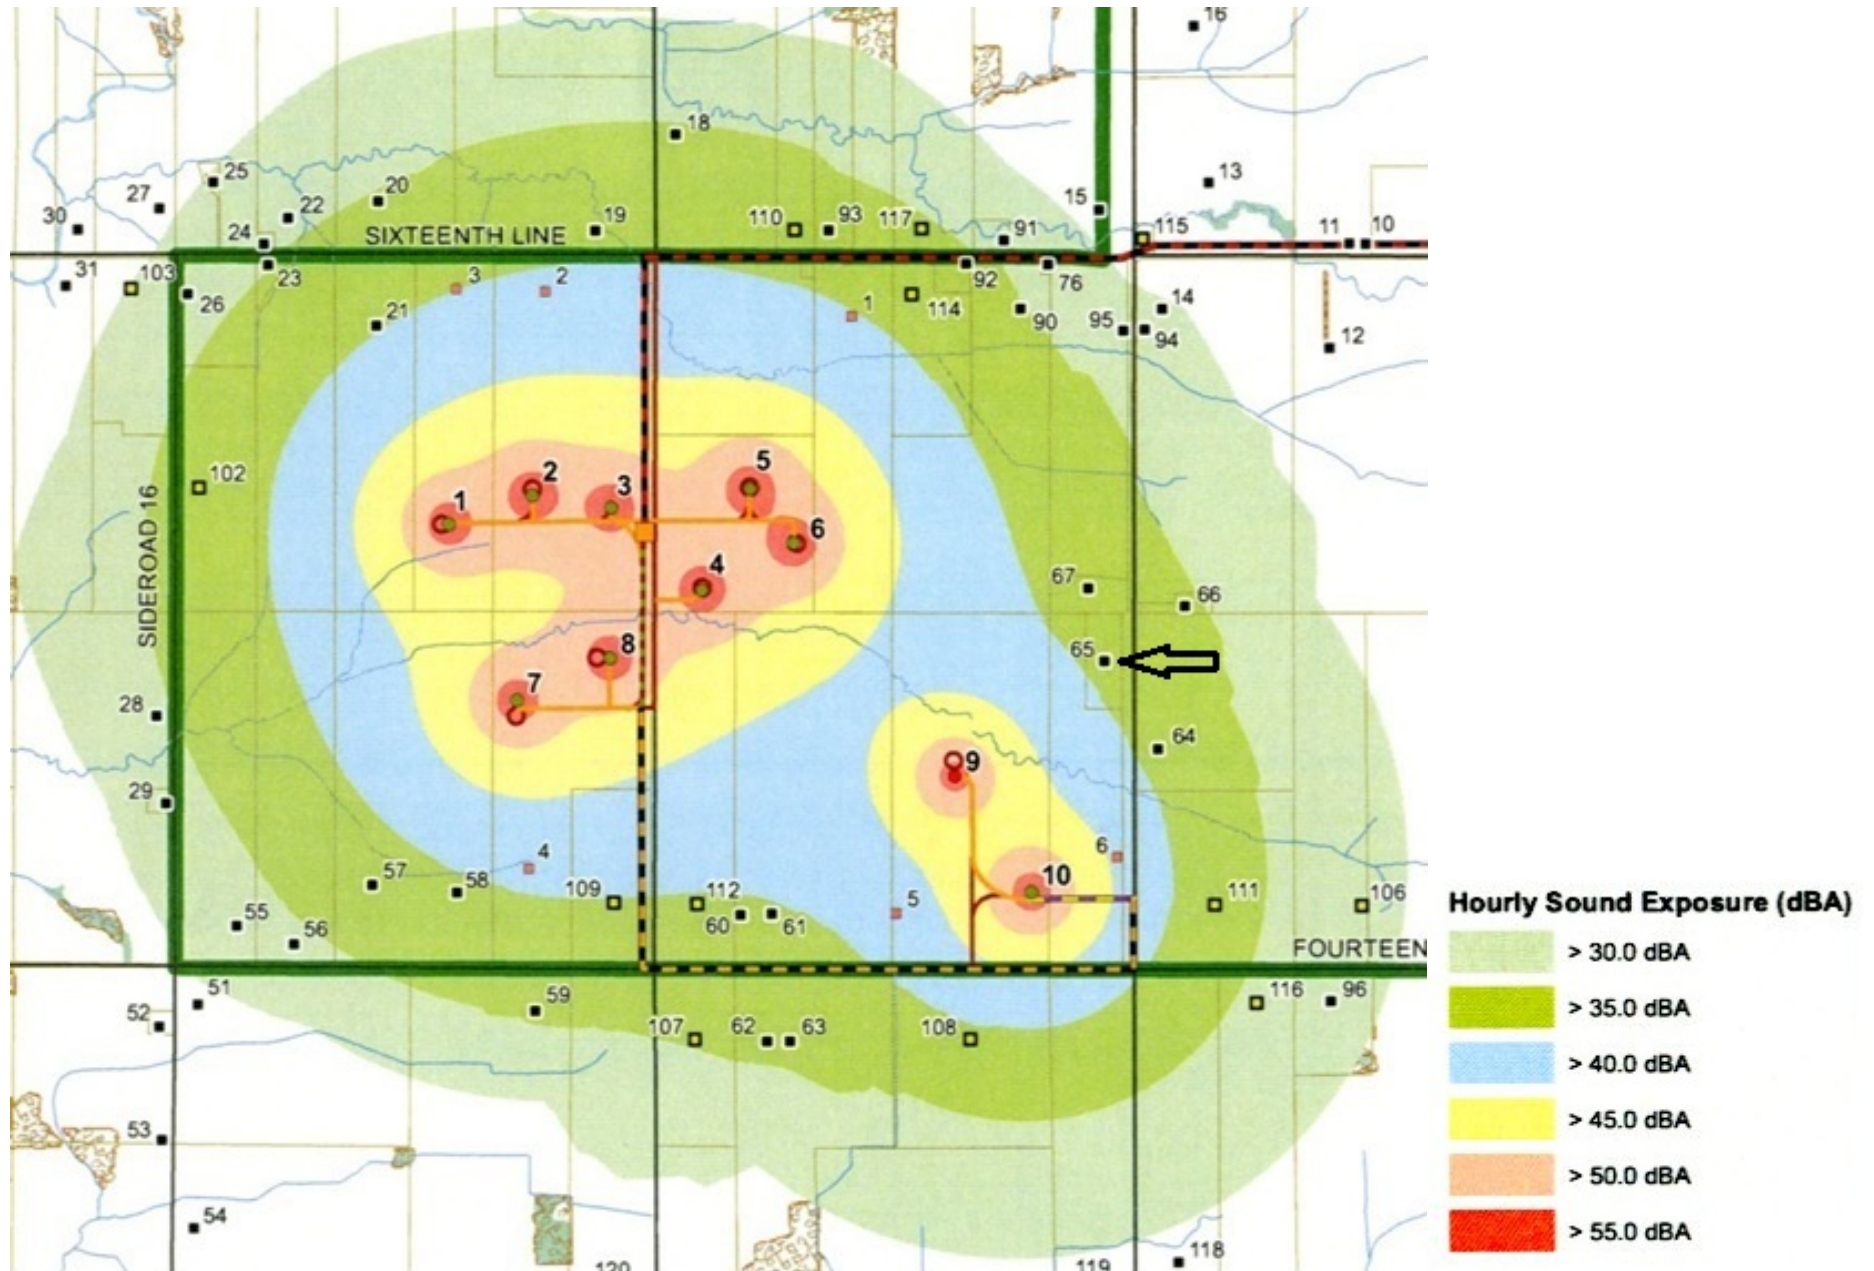
Appendix A – IWT layout 22.92 MW Conestogo Wind Farm near Arthur, ON.

From Noise Assessment Report by Genivar dated July 4, 2011.

The Weaver property abuts the 22.92 MW Conestogo Wind Farm in Mapleton Township near Arthur, ON. The wind farm consists of 9 Siemens AG2.3 MW IWT's and 1 Siemens AG 2.221 MW wind turbine. A location diagram is located in Appendix A. The Weaver residence is shown as receptor 65 where the "**worst case**" IWT sound levels were predicted to be 39.2 dBA by the proponent.
